Manhole Inspection Summary

Manhole # S13OO1002MH

Insp Date: **11/29/06 2:59 PM**

Location Address: **2801 RUSCOMBE LN**

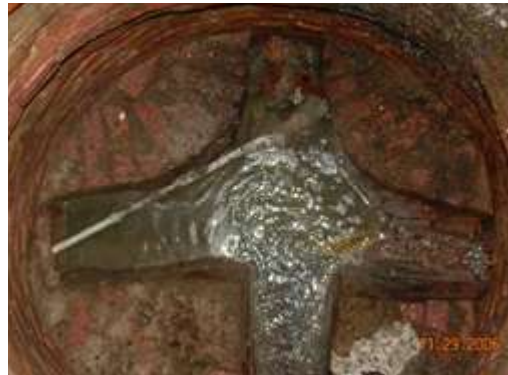
Top View

Bench and Channel debris.

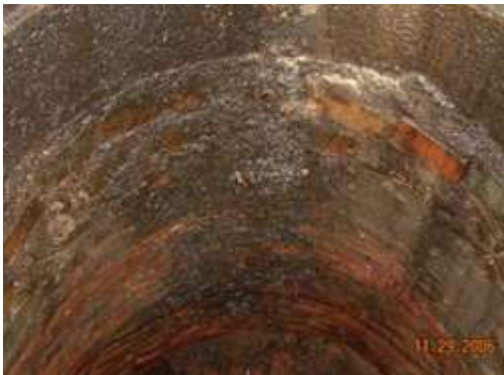
Defect

Frame leaks. Adjustment and Barrel infiltration.

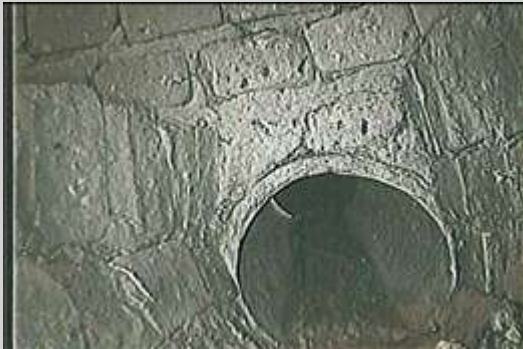
8 in. Circular Gravity Sewer Pipe Out @ 12 O'Clock

Comments **The O12 pipe picture shows Channel deterioration.**

Infiltration: **None** Pipe Seal Cond: **Cracked**

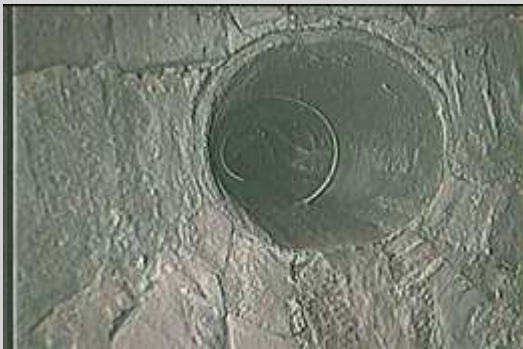
8 in. Circular Gravity Sewer Pipe In @ 3 O'Clock

Infiltration: **Evidence** Pipe Seal Cond: **Cracked**

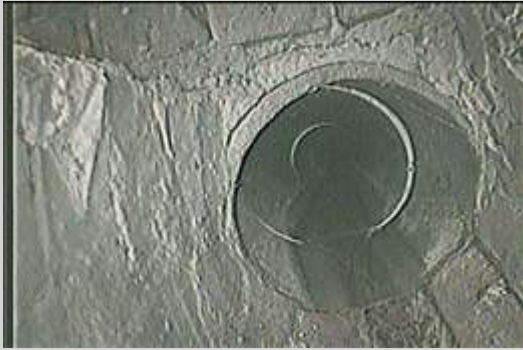
Pipe In @ 6 O'Clock

Deposits: ☐ None ☐ Mud ☐ Sludge ☐ Debris ☒ Grease

Silt Depth: **0** (in.) Deposits Extent: **Light**

Infiltration: **Evidence** Pipe Seal Cond: **Cracked**
